# ESTCP Cost and Performance Report

(WP-200819)

## Ultrasonic Guided Wave Technology for Non-invasive Assessment of Corrosion-induced Damage in Piping for Pollution Prevention in DOD Fuel Storage Facilities

September 2011

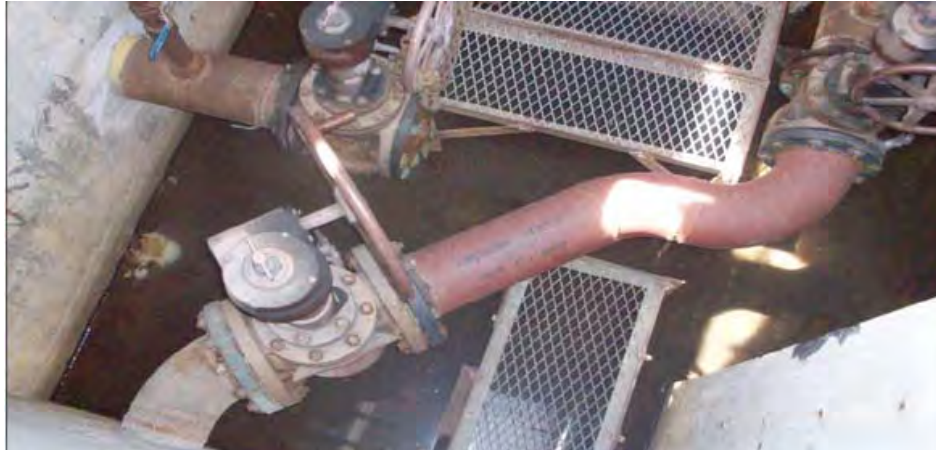
**Figure 3. Pipeline accessories inside a valve pit.**

JP-5 jet fuel in storage tanks on Craney Island supplies the needs of Navy aircrafts at Naval Station Norfolk via this pipeline that runs through the Elizabeth River before reaching the shores in Norfolk. Sections of the pipeline between VP 5 and VP 7 were deemed unpiggable because of the existence of internal obstructions and reducers and because of cost considerations for a relatively short line. An example of obstructions inside a valve pit is shown in Figure 3.

The second important aspect is that pipe sections typically have bends, elbows, valve attachments, and even flanges within the confined space of 5 to 15 ft inside the pit (see Figures 3 and 6b). These features have the following ramifications. First, guided wave cannot propagate across a flange. Its existence prevents the interrogation of the pipe in the direction away from the pit if a transducer cannot be placed between the flange and the wall in the valve pit. This was the situation in valve pits 21, 22, and 23 and thus limited wave propagation to one direction only away from the pit. Second, the characteristics of the waves in the forward and the reverse directions generated by one transducer would be very different since the complex components inside the pit strongly modified the waveform in the reverse direction. This had the consequence that attempts to compare the forward to the reverse waves to check for consistency in peak identification, as we did in Phase I, was not successful due to the significant distortions in wave propagation in the reverse direction.

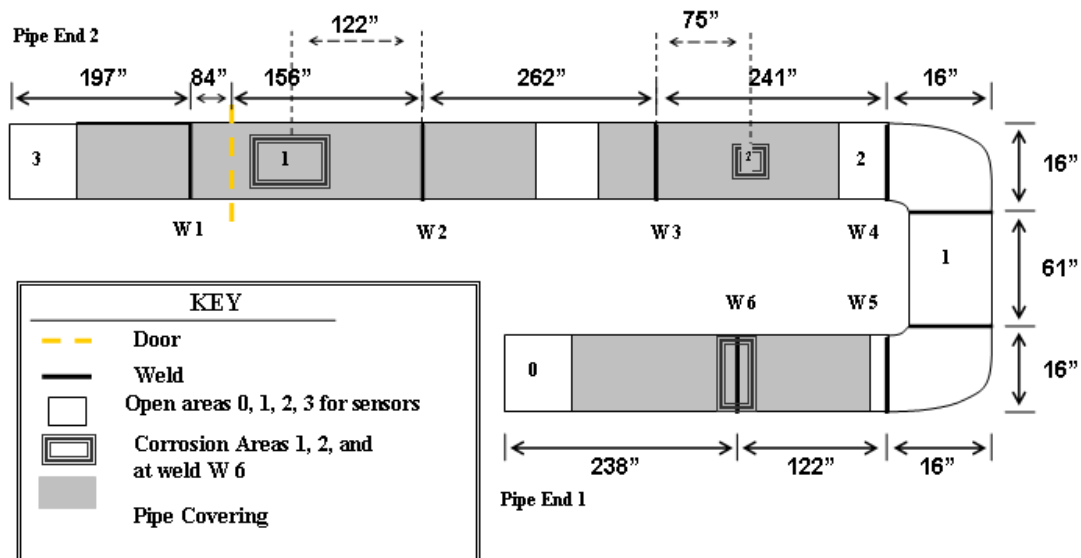
**Figure 4. Location of ultrasonic measurement points and corrosion defects in the 8.6-inch diameter pipeline at NSWCCD.**

Figure 4 illustrates the locations of the corrosion-induced defects. Two defects (unknown to the inspectors) were placed in the long straight sections of the pipeline. One of the defects not only increased systematically in its depth, but also along the pipe axis and along its circumference as the exposure progressed (Defect 1). The other defect was intended to be a "small" defect (Defect 2) having a fixed lateral dimension of approximately 3×3 inches, but with increasing material loss in the thickness direction. The goal was to achieve a wall thickness loss exceeding 50% in this defect by the end of Phase I.

In Figure 4, regions 0, 1, 2, and 3 show where transducers were mounted. We see that waves excited by Sensor 3 propagating in the negative direction should reach Defects 1 and 2 before reaching an elbow. Waves excited by Sensor 2 propagating in the positive direction should reach Defects 2 and 1 before it reaches the pipe end. Waves excited by Sensor 1 should see Defects 2 and 1 after crossing an elbow in the positive direction and see the Defect W6 in the negative direction after crossing an elbow. Waves excited by Sensor 0 and propagating in the positive direction sees Defect W6 before reaching either elbow and beyond.

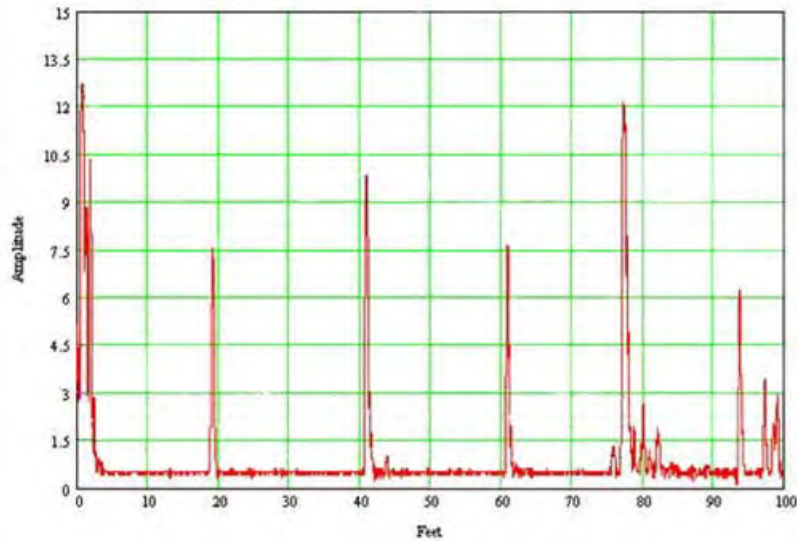
**Figure 8. Example of plotted ultrasonic guided wave baseline data for the aboveground coating system pipeline at NSWCCD before corrosion was initiated.**

An example of ultrasonic guided wave data showing peak height versus distance along the pipeline (see Figure 4) is shown in Figure 8. Wave propagation speed has been utilized to convert time of flight information to distance information along the pipe. In this figure, the large peaks are reflections from the welds. We note the existence of some small signal peaks with unknown origin before the initiation of corrosion that are not associated with welds. They could be caused by pipe stands, as-manufactured material anomalies, or other unknown conditions. We will come back to these points later in this report.

The plot shows peaks originating from welds, approximately 20 ft apart, as sensed by a transducer mounted in location 2.

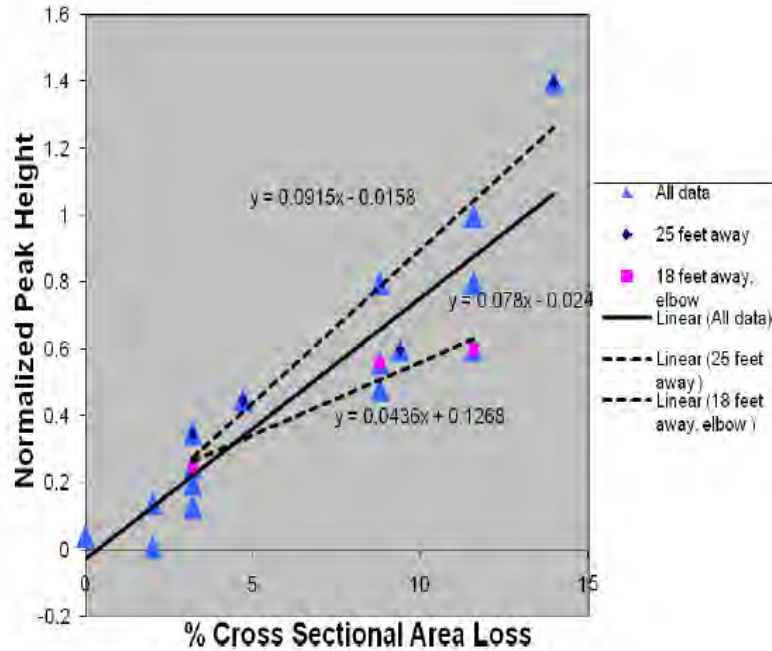
**Figure 10. Trend lines for the increase in signal height as the CSAL increases for data obtained in Phase I.**

Three trend lines are shown in Figure 10 to summarize the Phase I results. The solid line is based on all the data obtained in Phase I. It represents an averaged trend that provides an empirical “calibration” curve converting relative signal peak height to percentage CSAL for defects. The other two trend lines (dotted) were generated using the two subsets of data including the effects of an elbow (labeled “18 ft away” in the legend) and the ones representing the largest defects (labeled “25 ft away” in the legend). These two dotted trend lines provide the upper and lower bounds for the slope of the average trend line. Defects with 5% and 10% CSAL produced signal peak height of 0.35 and 0.65 volts, respectively, on the average trend line with uncertainties of approximately 25%. These uncertainties are the results of combining all the data obtained from different transducers, located at distances from 12 to 62 ft from the defect, the existence of a variable number of welds and an elbow, as well as defects of different area, volume, and shape.

If we focus our attention on the signals associated with a single transducer, as would be appropriate if we are only interested in measuring the changes of the system from a baseline condition, we realize that the slope of the trend line is mainly controlled by the variations of electronic noise and defect shape change over time. The details of the wave propagation across welds and elbows, as well as, scattering mechanisms affecting the absolute signal peak heights are less important when only signal changes are considered, since the effects of these variables (except for the size of the defect) are constant as a function of time. For the purpose of tracking defect growth, we observed in Figure 10 that the slope of the average trend line departs from those represented by the two extremes by no more or less than a factor of 2. Additional discussions of the Phase I results can be found in the Final Report (Liu et. al., 2011a) and a recently published paper (Liu et. al., 2011b).
